10 th January 2022	
	<h1>Draft Assessment Report – Flood Risk</h1> <h2>Surface Water to Marlingford</h2> <h3>21-105 Easton Phase 3 and 4</h3>	
1.0 Introduction	<p>An offer of service was made by 4D Geo Ltd (4D) to the client (Easton Parish Council) for a limited scope fee proposal for ground consultancy services including a report on flood risk at a site for proposed development at Easton Phase 3 and 4.</p> <p>The proposal was accepted, and the works instructed by email.</p> <p>Only a short period of time was available for this draft report and comments are brief as a result.</p> <p>The site covers approximately 16 Hectares (ha) on the west side of the village. Development comprises residential use by Persimmon Homes and is part of a wider masterplan for the village.</p> <p>The site area is approximately maximum dimension 550m west to east and 550m south to north with approximate elevation between 43 and 38m above Ordnance Datum (maOD). The site location is shown in Figure 1 extract from https://www.openstreetmap.org.</p>

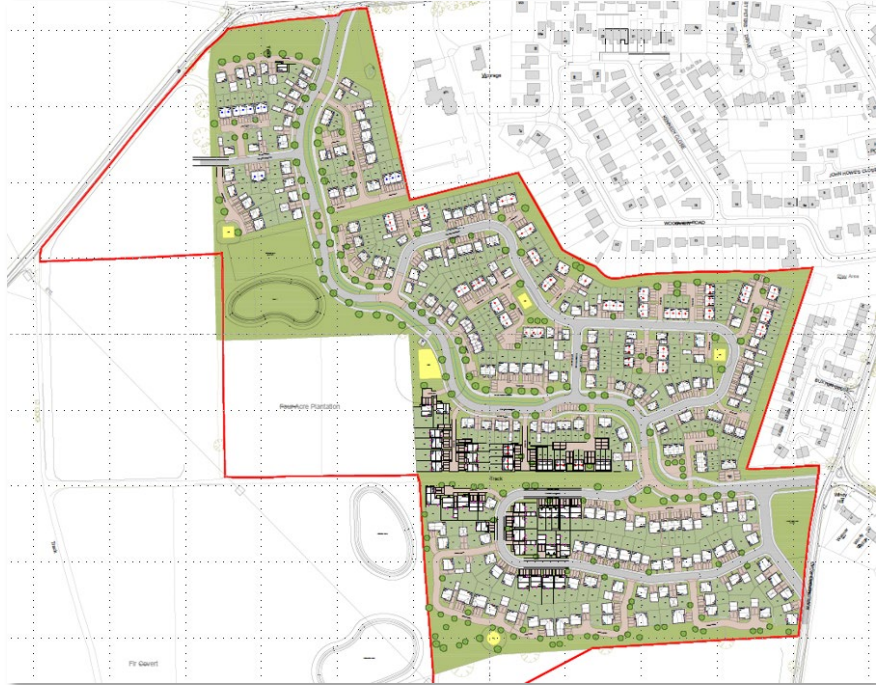
Figure 2

The proposed development is as shown in Figure 2.

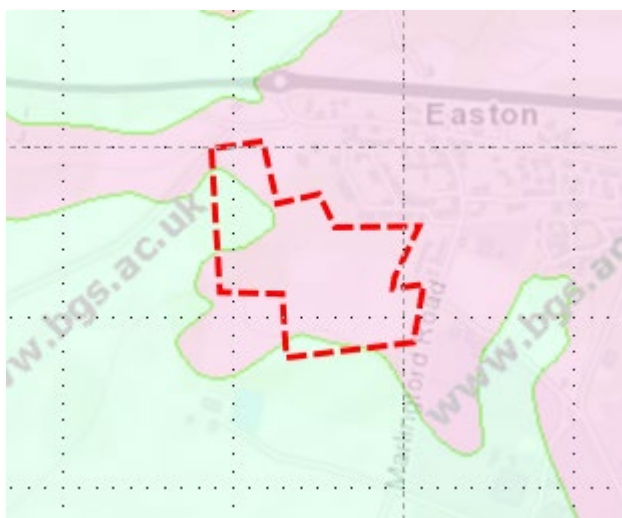
The map extract is shown below in Figure 3 including the approximate site location.

Pink is the sand and blue/green is the clay geology. Geology is mapped at surface with no regard for thickness of deposits. Knowledge of deposit thicknesses and characterisation in engineering is provided by ground investigations and archive borehole records.

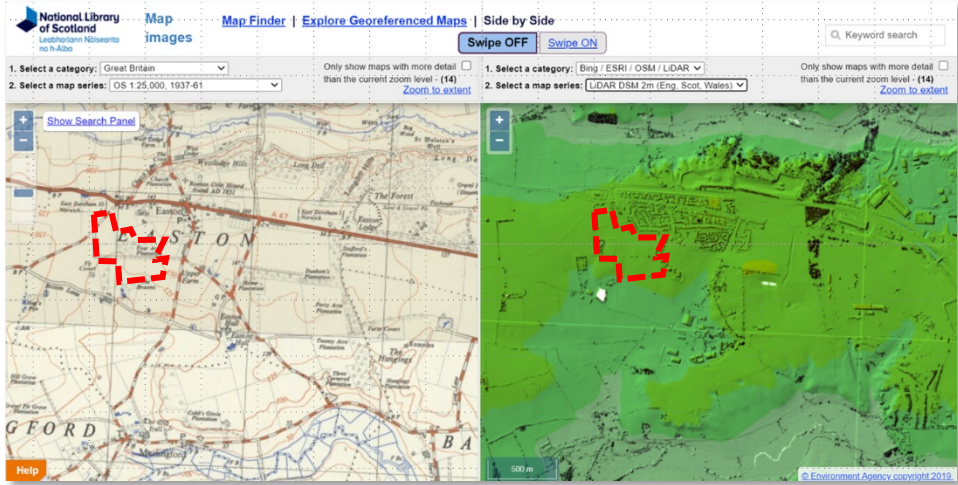
<p>In regional assessments over kilometre distances good generalisations can be made to fit observed facts such as the direction of river flows. There is risk in transferring generalisations to site scenarios without adequate characterisation of the ground conditions by investigation.</p>	
<p>4.2 Ordnance Survey Mapping and LiDAR</p>	<p>Ordnance Survey mapping and LiDAR (Light Detection and Ranging) is available freely on the internet at The National Library of Scotland https://maps.nls.uk/.</p> <p>Figure 4 below shows the site in a side-by-side format.</p>

<p>Figure 4</p> <p>The Ordnance Survey mapping shows valley feature by contours.</p> <p>The LiDAR image shading also reveals the valley features with extra detail.</p>	
<p>4.3 Groundwater</p>	<p>Government provides information on the environment in the UK including via https://magic.defra.gov.uk/MagicMap.aspx.</p> <p>Information on groundwater is provided under the Landscape heading. Aquifers are generally permeable and may be used for water resource and are ranked in order of how favourable/valuable they are from Principal to Unproductive.</p> <p>The approximate site location is shown in Figure 5 by a black arrow and the aquifer designation map shows the superficial deposits to be Secondary A for the sand.</p>

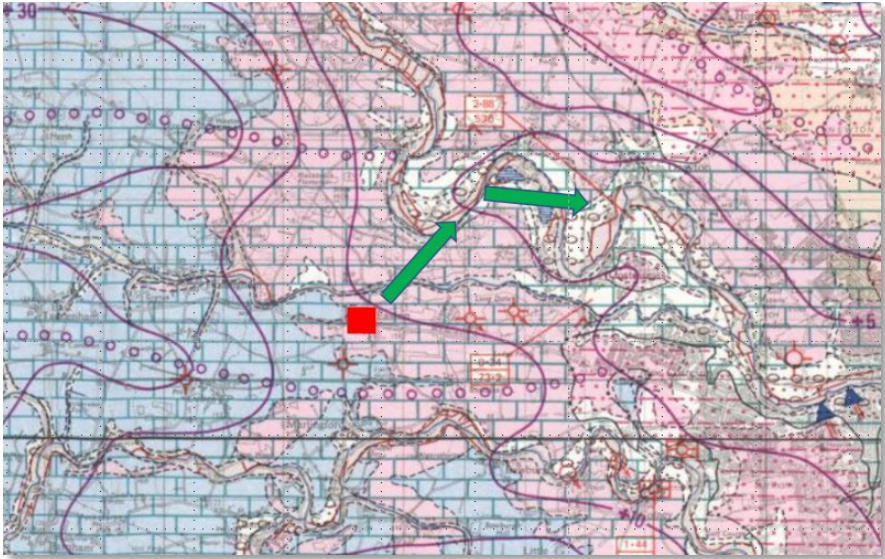
<https://webapps.bgs.ac.uk/data/maps/maps.cfc?method=viewRecord&mapId=11532> shows regional flow characteristics north and east as shown in Figure 7.

<p>Figure 7</p>	
<p>4.3</p> <p>Government</p> <p>Surface Water</p> <p>Flood Risk</p>	<p>The government publishes information on flooding by an interactive mapping service https://flood-warning-information.service.gov.uk/long-term-flood-risk/.</p> <p>Figure 8 below shows the site mapped for flood risk, low risk: velocity. Different map outputs can be obtained for different scenarios.</p> <p>Surface water flow is shown on to the site from the north and east. Flow paths are also shown to the west through the plantation and south to Marlingford/Yare via Broom Farm where there is an agricultural reservoir.</p>

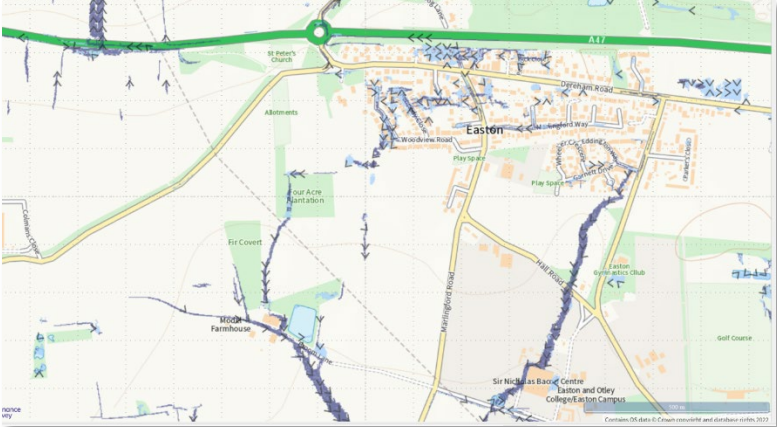
<p>Figure 8</p>	
<p>4.4</p> <p>Developer</p> <p>Report</p>	<p>The relevant developer's report is</p> <p>Schema Engineering Limited Hydraulic Modelling & Drainage Strategy Report Easton Phases 3 & 4, Norfolk Report Reference: 0156/HMRDS Revision A Date originated: 24th November 2021 Prepared for: Persimmon Homes (Anglia).</p>

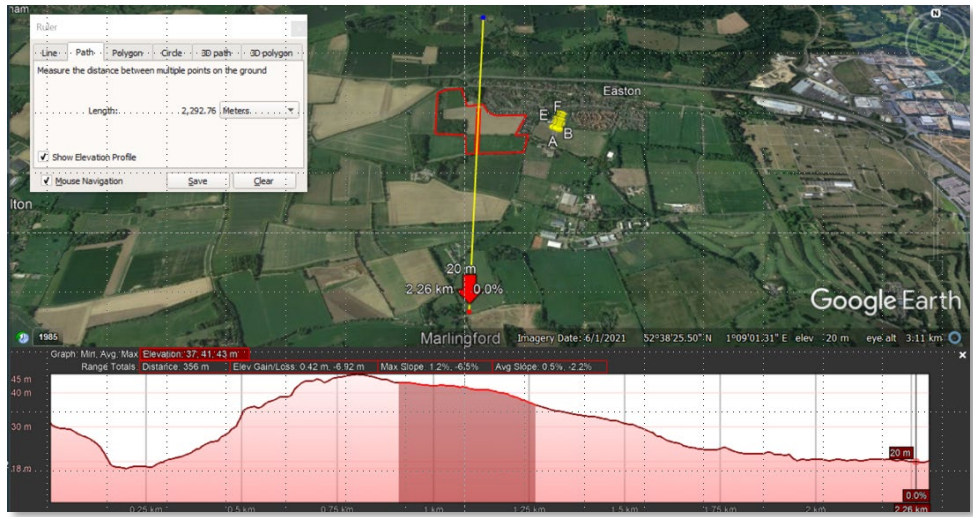
<p>Figure 9</p>

4.8 Adjacent Development	<p>No relevant adjacent development was researched at this stage.</p>	
5.0 Ground Model	<p>The evidence above is used to construct 2 & 3 dimensional models of the topography over the geology.</p> <p>Outputs from the model are qualitative and generally subjective to be validated by consultation and additional testing.</p> <p>Due to the need for models to be visualised, vertical exaggeration is used to draw the geology. A section between the River Tud and Marlingford through the site at Easton has been used taken from Google Earth as Figure 9.</p>

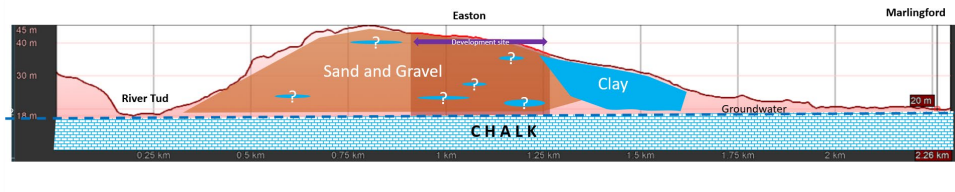
<p>Figure 11</p>	
<p>5.2 Pre-development Drainage Model</p>	<p>The pre-development drainage model is simplified to show some assumptions regarding flow directions in Figure 12.</p>

<p>Figure 10</p>	
<p>5.1 Preliminary Geological Ground Model</p>	<p>The geological model is developed in Figure 11 using a vertical exaggeration and interpretation of various sources.</p>

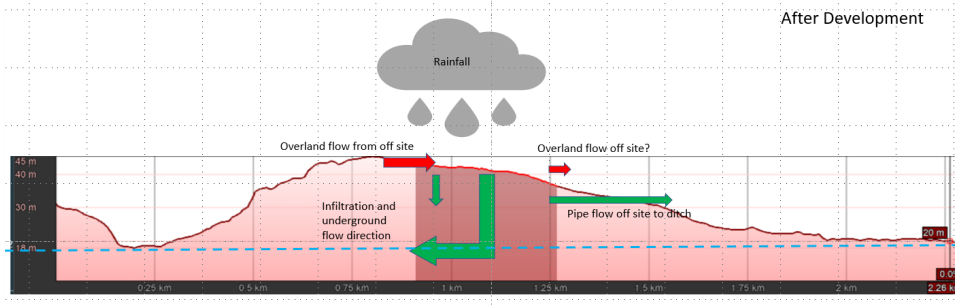
<p>Figure 13</p>

<p>Figure 12</p>	
<p>5.3 Post-development Model</p>	<p>After development the model is adapted to reduce overland flow to zero or near zero, but pipe flow to ditch is included outfall at Easton College nearer to Marlingford. We note implications of flows and quantities are not fully understood.</p>

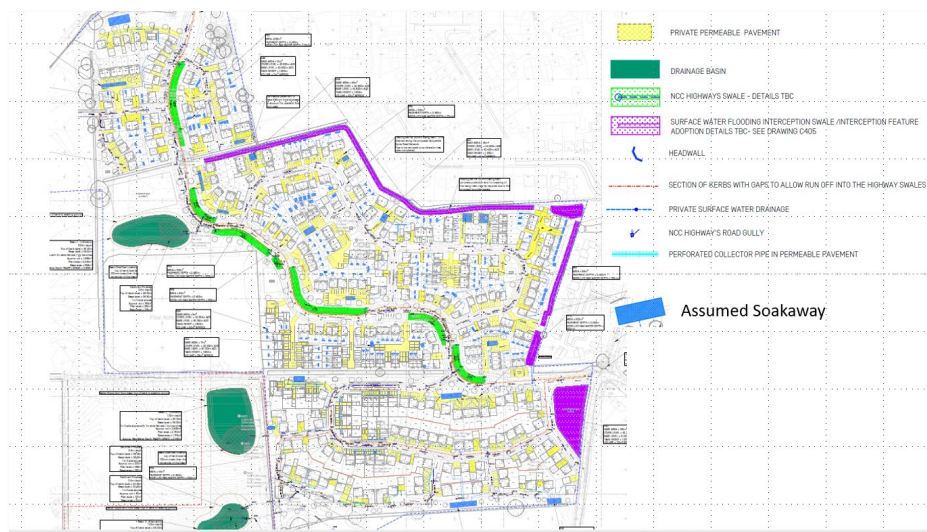
The engineering proposal drawing in Figure 15 shows how overland flows from off site would be intercepted on the north east boundary and a swale runs from north to south east. Many roofs are drained to soakaways (assumed in legend) but some are drained to basins. Permeable paving is widely used either soaking or diverted to basins. Highway drains to basins. Two basins are infiltration; north and middle. One basin (south) is attenuation.

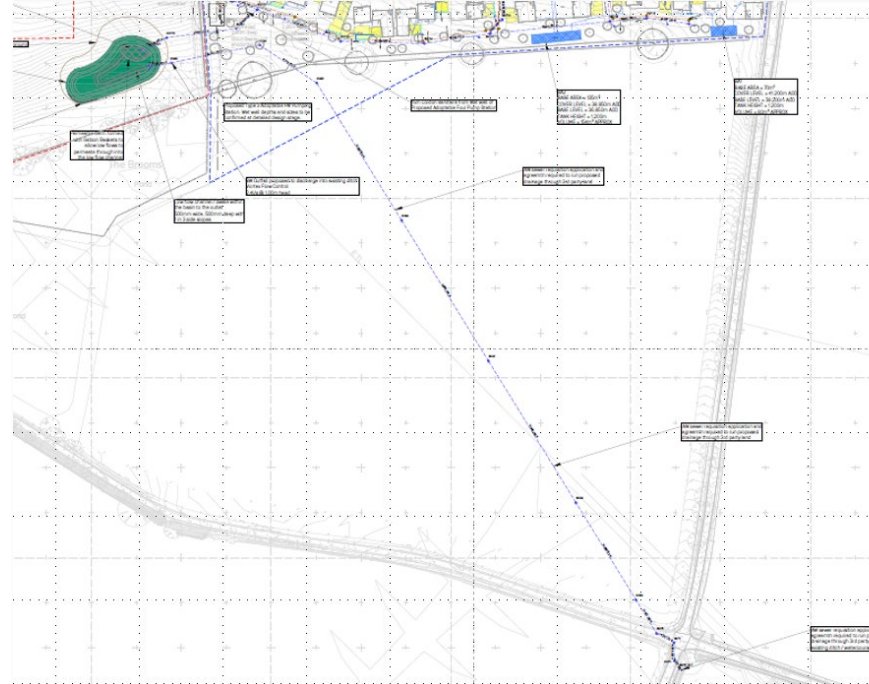
From the south attenuation basin, a pipe is shown crossing fields to the crossroads west of Easton College into ditches as Figure 16.

<p>Engineering Proposal Off-site South Pipe</p>

<p>Figure 16</p>	
<p>6.0 Comments</p>	<p>Initial comments are as follows;</p> <p>On site flows have been identified as set out in the researches from overland to the north, and rainfall.</p> <p>Current site drainage appears to be by infiltration through topsoil and overland flow south; at least partially contributing to the drain water courses above Marlingford. Roads between Marlingford and Easton have surface water in evidence during rainfall.</p> <p>Although an apparently compliant set of testing has been undertaken, the fieldwork concentrates on the ground level to 0.8-3.5m depth range. One borehole from the original planning application has been discovered to 10m depth. Long term groundwater levels or the presence of any unfavourable clay layers has not been provided. The checklist from The SUDs Manual has not been presented.</p> <p>Engineering proposals for the development intercept and divert surface water to infiltration devices; soakaways, swales, permeable paving and basins. Where flow exceeds overall capacity, a pipe distributes to a ditch west of Easton College above Marlingford.</p> <p>Quantities of flows are not understood at this stage so risk estimation to flooding Marlingford via ditches during exceedance are not known.</p> <p>Infiltration devices are observed likely to work well, although there is potential opportunity for further testing and design detailing. It is noted topsoil has been included as part of some tests which is assumed not to</p>
